FTA ALTERNATIVES ANALYSIS
DRAFT/FINAL ENVIRONMENTAL IMPACT STATEMENT

The Connecticut Department of Transportation (ConnDOT) has initiated a feasibility study to examine the needs of and identify potential improvements to the New Haven Line's commuter rail branch line service between Norwalk and Danbury. A Congressional earmark has provided the funding for the study, which has been divided into two phases. Phase I of the study has been completed and included the identification, review, and evaluation of a range of preliminary improvement alternatives to the branch, including electrification, addition of passing sidings, extension of service to New Milford, and track realignment modifications. Phase II of the study has begun and will constitute an environmental impact analysis and documentation for proposed action(s) following the National Environmental Policy Act (NEPA) and Connecticut Environmental Policy Act (CEPA) process.

This report documents the existing conditions of the Rail Infrastructure. It summarizes existing conditions between Norwalk and New Milford as determined from a review of existing documents and from Phase II research and field investigations. Expansion of the

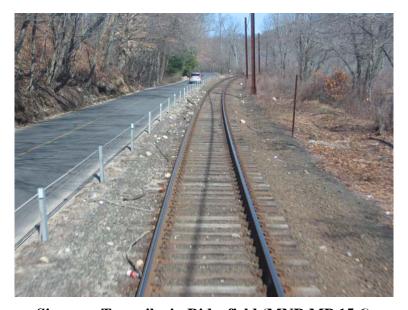
Simpaug Turnpike in Ridgefield (MNR MP 15.6)

Several tight horizontal and vertical clearances currently exist on the Danbury Branch, including various rock cuts, overhead highway bridges and the Wall Street Tunnel in Norwalk. One concern raised by the Office of Rail is the horizontal clearance located in Ridgefield where Simpaug Turnpike closely parallels the railroad line, as pictured below. At this location the roadway and ballast abut each other.

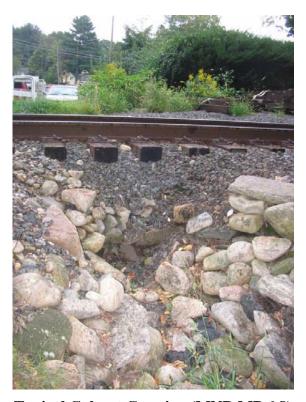
Typical drainage conditions along the Danbury Branch line consists of runoff from the railroad tracks naturally draining into watercourses and wetlands that are adjacent to the railroad tracks. These watercourses include the Norwalk River, Still River and Housatonic River. There are a number of culverts that cross under railroad tracks that allow drainage to cross from one side of the tracks to another to adjacent streams or wetlands. A typical culvert crossing is pictured below and carries drainage from one wetland area to another wetland area on the other side of the tracks.

Typical Culvert Crossing (MNR MP 6.8)

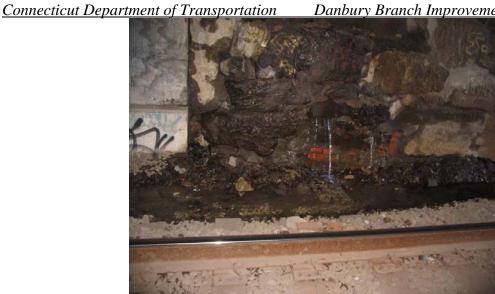
There were several drainage issues noted between the South Norwalk Station and the old New Milford Station. One of the most notable drainage problems noted was at the Wall Street Tunnel (MP 1.5) pictured below. Water is leaking from the east abutment wall resulting in standing water all along the east side of the tracks for the majority of the length of the tunnel.

Water Leakage at East Abutment at Wall Street Tunnel (MNR MP 1.50)

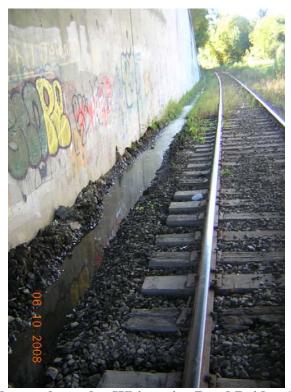
Photographed below is the drainage issue underneath the Whisconier Road Bridge along the HRR – Berkshire Line segment of the railroad line. Runoff from the bridge overpass drains into this area. Standing water is present along the tracks for the length of the bridge and beyond.

Standing water by tracks under Whisconier Road Bridge (HRR – Berkshire Line)

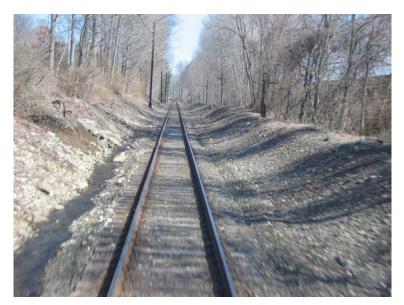
Standing water is adjacent to the tracks is a common drainage issue along the tracks. Pictured below is standing water along the west side that meanders across the tracks. A similar drainage Connecticut Department of Transportation Danbury Branch Improvement Program AA/DEIS

Standing Water along West Side of Tracks (MNR MP 4.70)

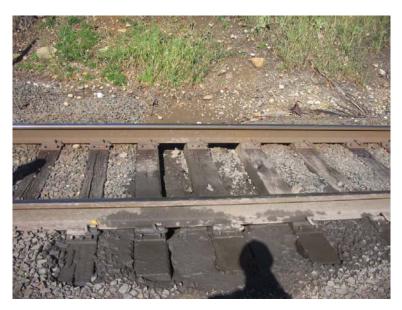
In some locations, poor drainage has caused ballast washout within the tracks and erosion at the base of the cross ties. Photographed below is a washout observed at MP 9.4 along the MNR segment of the rail line.

Poor Drainage (MNR MP 9.40)

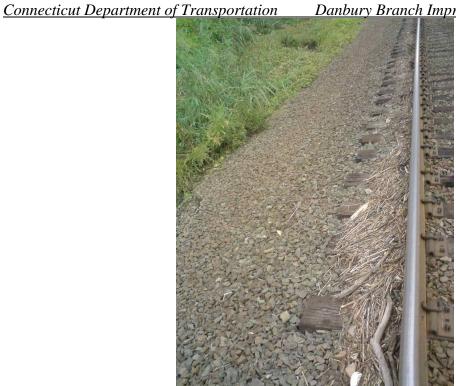
There is a segment of the tracks just north of the Bethel Station that is surrounded by wetlands on both sides and floods during heavy rain storms. Photographed below is debris along the outside of the tracks at this location, indicating that flooding was high enough to reach the top of rail.

Debris along Tracks due to Flooding (MNR MP 21.3)

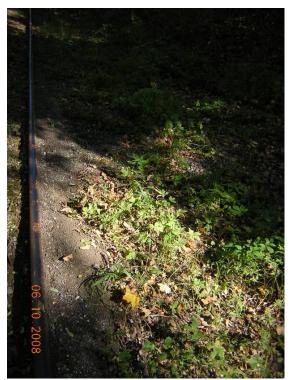
The photograph below was taken along the HRR – Berkshire Line segment of the Danbury line. As shown, sediment from runoff has built up along the tracks to the top of rail.

Sediment Build-up at Tracks (HRR - Berkshire Line MP 1.5)
